Case Study: Rehabilitation of a Preaction Fire Protection System affected by internal corrosion

South-Tek Systems, LLC
2940 Orville Wright Way, Suite 600
Wilmington, NC 28405
Tel: (888) 526-6284
E-mail: info@southteksystems.com
www.southteksystems.com

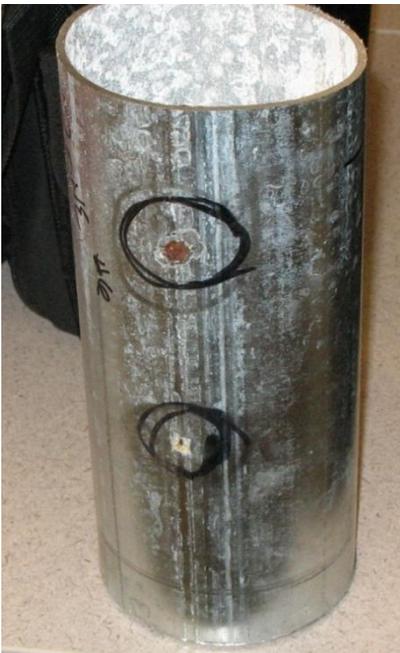
A mission-critical data processing, video post-production, and broadcasting facility started to experience pinhole leaks in their Preaction Fire Protection System approximately two-and-a-half years after completion and commissioning of the facility (**Figure 1**).

Figure 1. Pinhole leaks on galvanized, Schedule 40 piping from 2 ½ year old Preaction system.

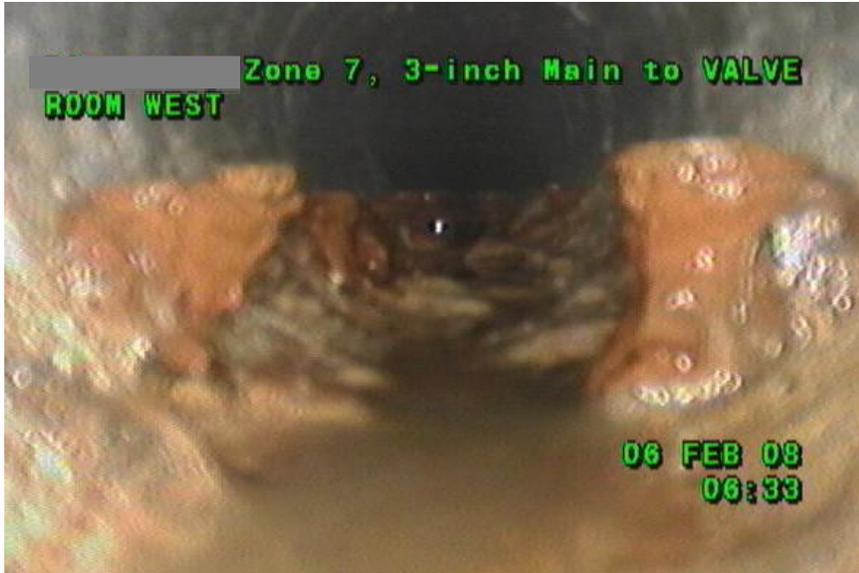
After occurrence of numerous pinhole leaks, the building owner hired a 3rd party industry expert to conduct internal video-borescoping which revealed areas of residual water with significant accumulation of white corrosion product deposits (originating from the zinc corrosion) interspersed with reddish-brown tubercles (originating from the corrosion of the underlying steel). A representative video-borescope image of the as-found internal condition of the pipe is shown in Figure 2.

Figure 2. Representative image of pipe interior approximately 2 ½ years after installation.

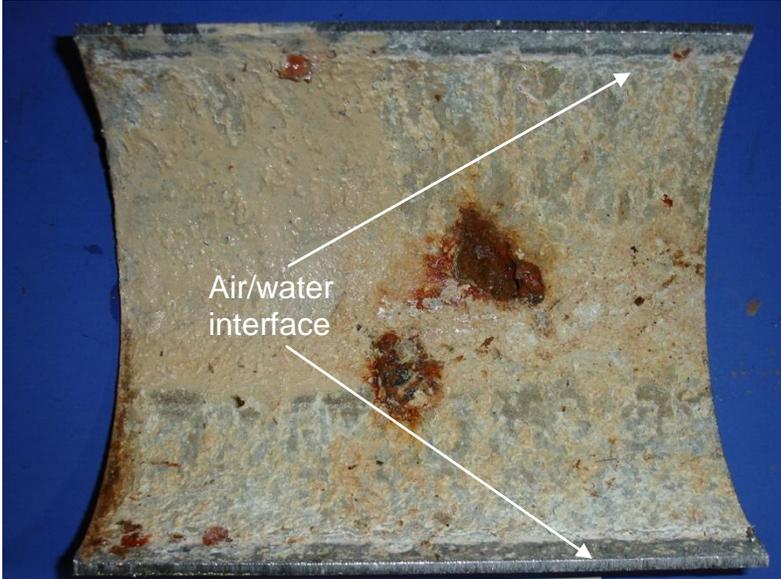
Figure 3. Overall view of as-found condition of bottom half of 6" main pipe sample after longitudinal sectioning (Note indicated air/water interface and localized tubercles).

Based on these results it was concluded that the observed corrosion was the result of the combined effect of residual water and the Oxygen in the supervisory air. The supervisory compressed air acts as a source of Oxygen to sustain localized corrosion in the areas where a two-phase system (residual water with a blanket of compressed air above it) exists. Localized pitting had occurred underneath the corrosion product deposits resulting in the formation of localized differential aeration cells, subsequent through-wall corrosion and loss of wall thickness of the surrounding base material.

Based on the overall condition of the piping and the unpredictability of pitting penetration rates, a decision was made to replace the 4" and 6" mains along with the cross mains throughout the seven Preaction systems. The General Contractor bore the majority of the costs to replace the affected sprinkler piping. Due to the requirement that the facility was to remain fully operational during the entire pipe replacement project and the presence of other installed equipment such as ducting, electrical service, cooling and heating piping, communications and video wiring, a complete re-sloping

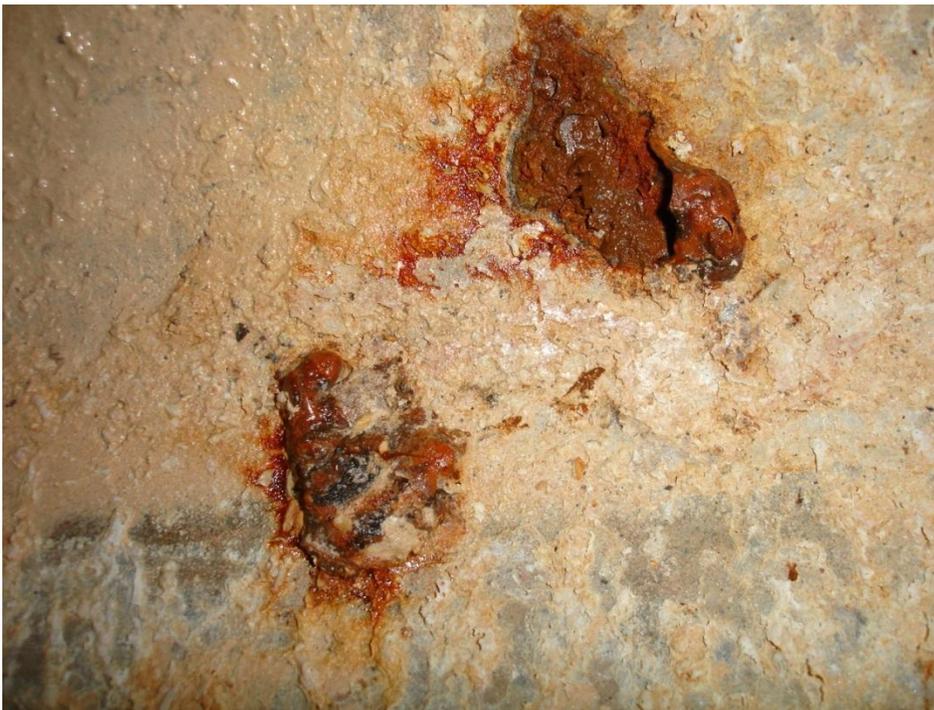
Figure 4. Close-up view of localized tubercles under air/water interface on interior surface of pipe sample (Note reddish-brown color of tubercles indicative of ongoing corrosion of the underlying steel pipe wall).

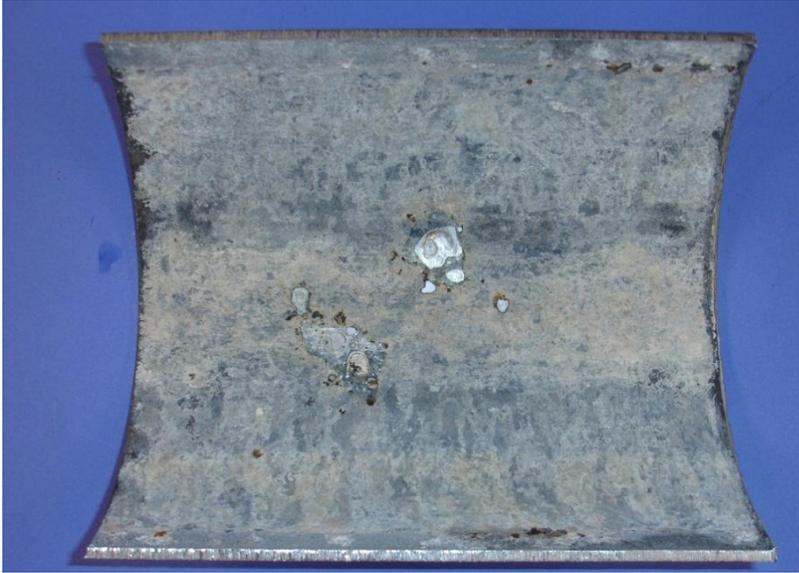
Figure 5. Overall view of as-found condition of bottom half of 6" main sample after removal of corrosion product deposits.

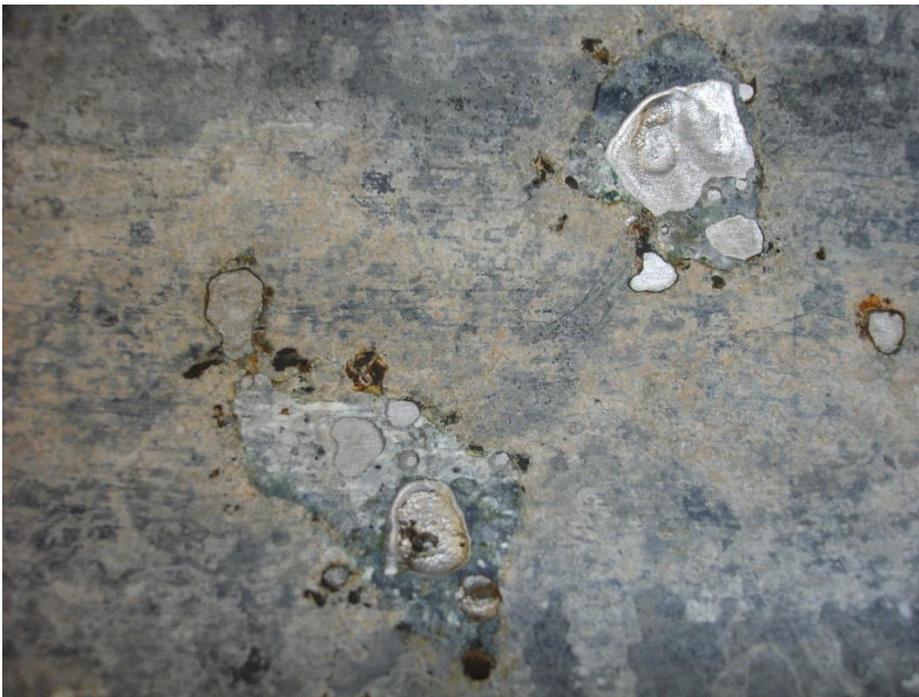
Figure 6. Close-up view of interior pipe surface condition of bottom half of 6" main sample after removal of corrosion product deposits (Note shiny localized pits indicative of active, ongoing localized corrosion).

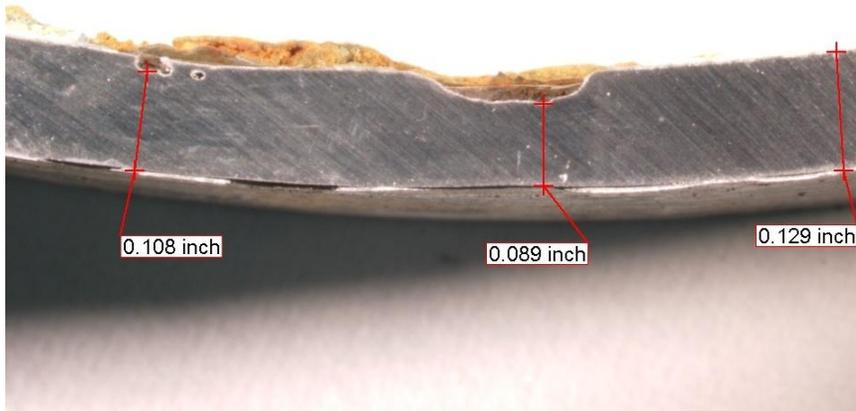
Figure 7. Cross-sectional view of corrosion pit in 6" pipe sample showing penetration of approximately 34% based on nominal wall thickness of 0.134" (Magnification: 5X).

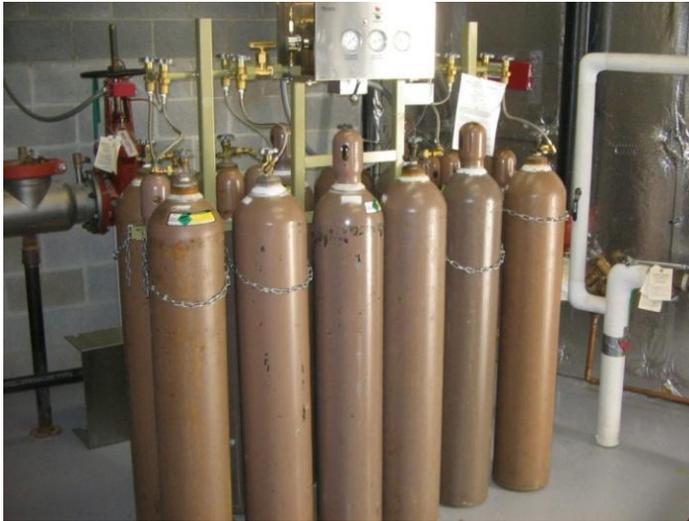
Figure 8. Nitrogen cylinder manifold for supervision of the Preaction system

This system performed satisfactorily for approximately 1 ½ years, but the effort and danger associated with the ongoing shuttling of Nitrogen cylinders made it less than optimal. In addition, the cylinders provided only a finite supply of Nitrogen gas and therefore required personnel and time to constantly monitor the supply of Nitrogen within the cylinders.

of the system was impossible. A decision was made to install and/or reposition manual, auxiliary drains wherever deemed necessary and convert the system to a Nitrogen-supervised system to prevent the recurrence of Oxygen-driven, internal corrosion. At the time, the only viable source of high-purity Nitrogen was either liquid Nitrogen from an outside tank or high pressure cylinders. A custom designed manifold was installed with two banks of high pressure Nitrogen gas cylinders to facilitate an uninterrupted Nitrogen supply during a switch from one bank to another.

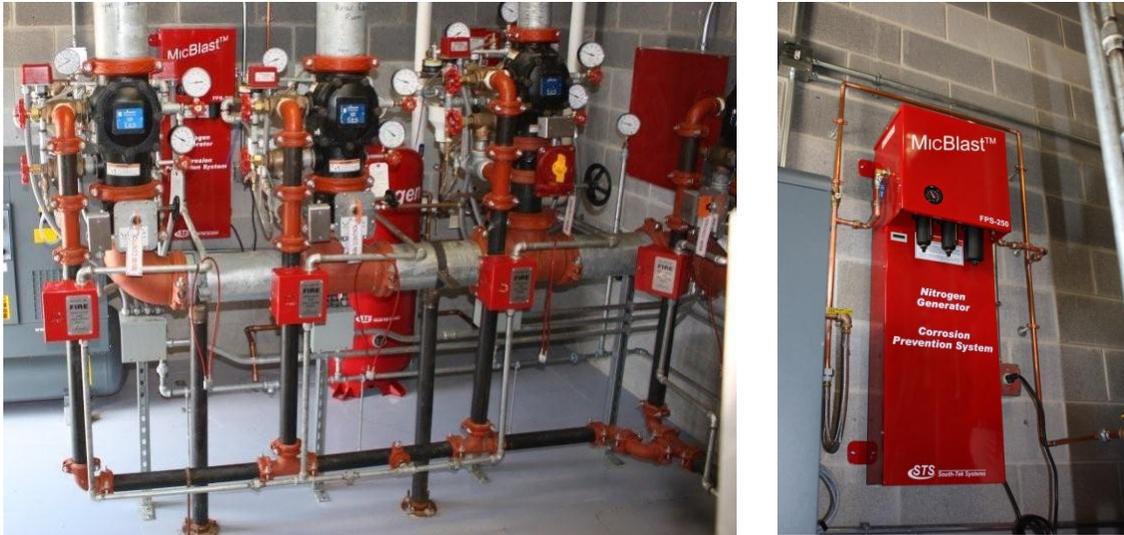
Figure 9. Nitrogen generator system for supervision of Preaction system

This turn-key system was installed approximately four years ago and has performed above expectations. The maintenance has been minimal, requiring only annual oil changes and compressor air filter replacements. Annual inspections to assess the condition of the newly installed piping have revealed no indications of recurrence of the localized corrosion. The source of city water being utilized for hydrotesting and the working conditions of the piping remain unchanged. Currently, the corrosion penetration rates are negligible and no pipe replacement has been warranted since the introduction of Supervisory Nitrogen approximately 5 ½ years ago.

With the advent of Nitrogen Generation Systems designed to be integrated into Fire Protection Systems, it was advantageous to replace the bottled Nitrogen manifold with a single, pre-packaged Nitrogen Generation System, thus eliminating the risks associated with high pressure Nitrogen cylinders.
