# Steel Piping Material Corrosion

## Dry and Pre-Action Fire Protection Systems

PAUL SU & DAVID B. FULLER | FM Global

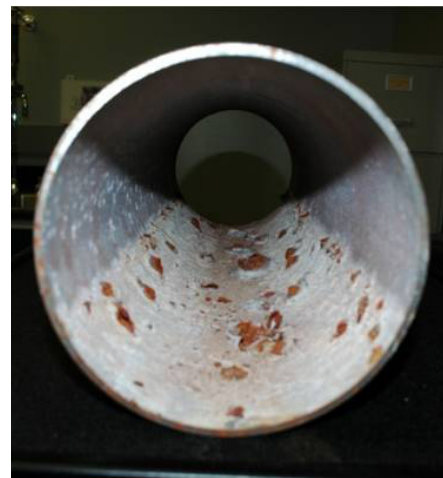
Figure 1 shows corrosion of galvanized steel pipe (NPS 6, schedule 10) where trapped water filled about 40 percent of the pipe’s volume in a dry pipe system. Under the water line, white rust (zinc corrosion) and well over a dozen reddish-brown tubercles of various sizes are evident on the bottom half of the pipe. (See Figure 1.)

Figure 1. Photograph showing corrosion of galvanized steel pipe (NPS 6, schedule 10) where residual water filled about 40 percent of the pipe’s volume in a pre-action system.

The white rust, zinc corrosion for galvanized steel pipe, mainly includes zinc hydroxide ( $Zn(OH)_2$ ), zinc carbonate ( $ZnCO_3$ ), and zinc oxide ( $ZnO$ ). White rust and corrosion tubercles shown in Figure 1 are friable, soft and usually hollow inside. Therefore, they are not likely to clog the pipe or sprinklers.

**C Value Calculation** Since galvanized pipes do corrode, there is a concern that the hydraulic friction loss constant,  $C = 120$ , may not accurately reflect the interior condition of a galvanized sprinkler pipe. This concern is unwarranted due to safety margin that is built into the C-factor used for sprinkler system calculations and the type of corrosion that occurs in galvanized pipe. In poorly maintained systems, the C-factor can be negatively affected by the effects of pipe interior corrosion, however there is a significant safety margin used in the friction loss calculations to avoid unacceptable performance (all new pipe has a C-factor much higher than 120). The nature of galvanized pipe corrosion leaves much of the sprinkler pipe surface in good condition (certainly much better than black steel wet sprinkler piping for which a C-factor of 120 is used for calculations; e.g., Figure 1 vs. Figure 2) and therefore the C-factor of 120 remains appropriate.

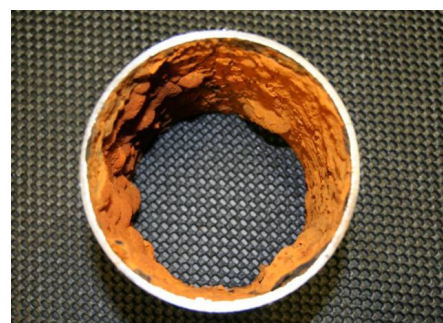
*b) Black Steel Pipe* Figure 2 shows tubercles heavily formed inside a black steel sprinkler pipe (NPS 4, schedule 10) for a wet pipe system, with through-wall pinhole leakage at the base of a tubercle. The reddish-brown iron (III) hydroxide ( $Fe(OH)_3$ , rust) corrosion product covers tubercle surfaces. If the black steel pipe installed in a dry or pre-action system with trapped water filled 40 percent of the pipe’s volume similar to conditions described in Figure 1, heavy formation of tubercles can also be expected from the lower section. (See Figure 2.)

Figure 2. Photograph showing tubercles heavily formed inside a black steel sprinkler pipe (NPS 4, schedule 10).

Corrosion products from black steel pipe mainly include iron(III) hydroxide ( $Fe(OH)_3$ ), iron(II) hydroxide ( $Fe(OH)_2$ ), and magnetite ( $Fe_3O_4$ ). The corrosion scale and tubercles shown in Figure 2 can be soft-friable or dense-hard depending on their growth rates. The harder dense tubercles tend to grow slower than softer friable tubercles, and could potentially clog the pipe or sprinklers, if large and hard

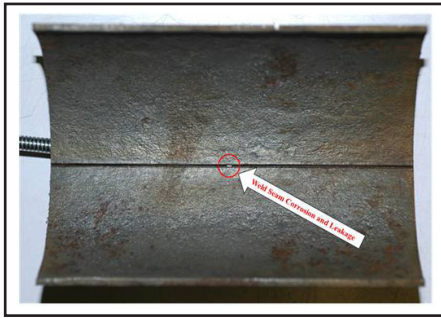
Figure 3. Photograph showing preferential grooving corrosion on pipe weld seam with a 1 mm pinhole leakage inside a black steel pipe (NPS 3, schedule 10).

Grooving corrosion at the pipe weld seam can occur in all welded seam sprinkler pipe and can be exacerbated by installing the pipe weld seam oriented toward the floor, leading to under-deposit corrosion of pipe weld seam. Figure 3 shows an example of preferential grooving corrosion on a pipe weld seam with a 1-mm pinhole leak in a black steel pipe, after removing corrosion products inside a black steel pipe (NPS 3, schedule 10).

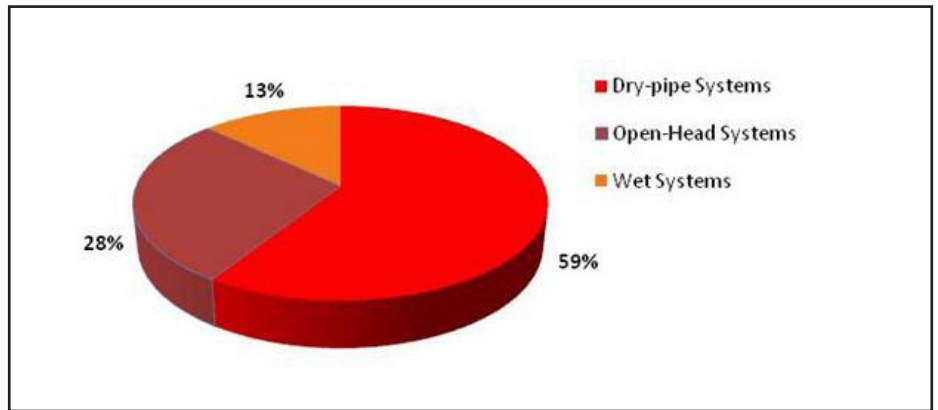
**FM Global Loss Experience** Figure 4 shows that the dry-type sprinkler systems (dry and pre-action) are involved in the majority (59 percent) of fire losses caused by corrosion related

Figure 4. Sprinkler systems involved in Obstructed-Pipe Fires: (Losses reported to FM Global 1982-2001).

obstruction of sprinkler flow, based on FM Global's loss data (history, 1982-2001) analysis described in "Understanding the Hazard – Dry-Pipe Sprinkler Systems Flushing Investigations."<sup>5</sup> It should be noted that this loss data analysis for dry systems predominantly involves black steel pipe. The hard and dense corrosion tubercles in black steel pipe were found to be the most frequent obstructing material.
