TECHNICAL REPORT

CORROSION IN DRY AND PREACTION SYSTEMS: RESULTS OF LONG-TERM CORROSION TESTING UNDER COMPRESSED AIR AND NITROGEN SUPERVISION AFTER 2398 DAYS OF EXPOSURE

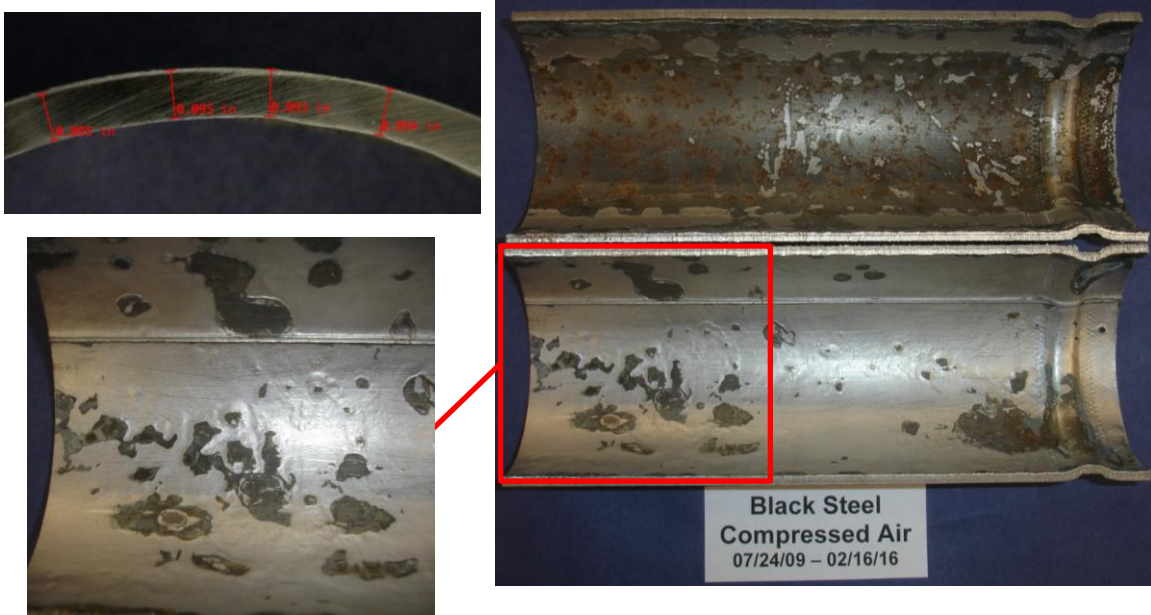
Figure 1. Composite image of cleaned black steel piping after 2398 days exposure while half-filled with water and under compressed air supervision. Note uniform thinning of pipe wall with a few localized, shallow pits.

Examination of the tested black steel pipe spool samples under compressed air supervision showed mostly uniform loss in thickness of the pipe wall in the portion of the pipe that was submerged in water. A small number of wide, shallow, localized pits were

noted in the pipe under compressed air supervision. Representative images of the pipe samples after removal of corrosion product deposits are presented in Figures 1-6. Wall thinning had occurred evenly in the wetted portion of the partially filled pipe, but some localized pitting appears to have initiated as well (Field observations of long-term service, failed black steel pipe under compressed air supervision have shown pinholes associated with localized pits. However, it has been observed that such pits only occur after development of differential aeration cells under a thick layer of corrosion product deposits and/or tubercles. As shown by the reported results of the exposure testing, the mechanism for the initial several years is uniform corrosion resulting in relatively uniform thinning of the pipe wall.).

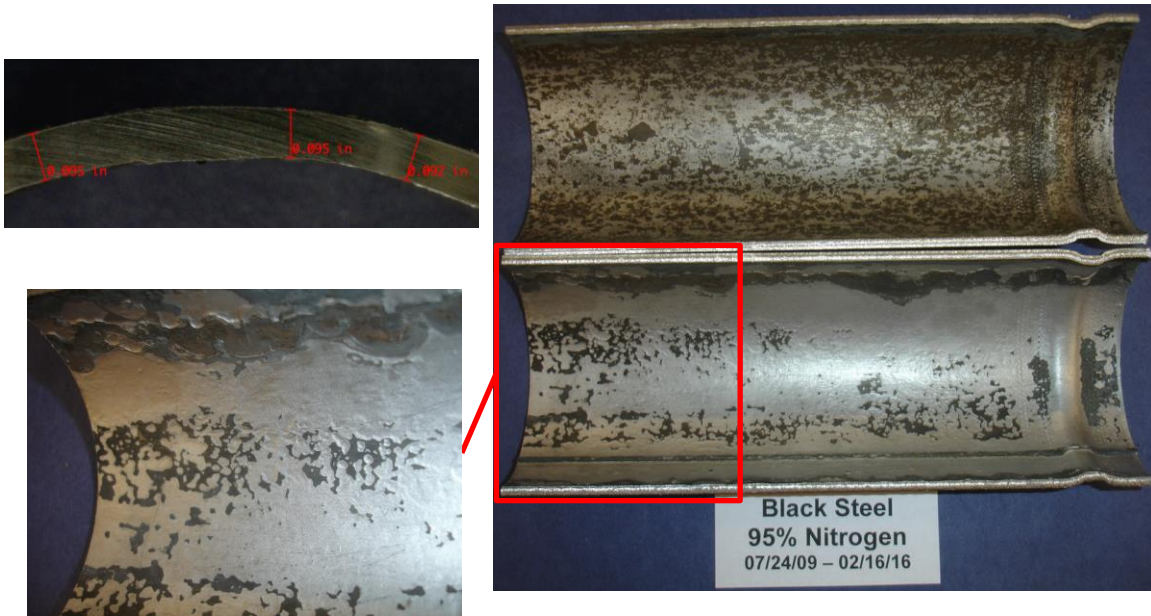
Figure 3. Composite image of cleaned black steel piping after 2398 days exposure while half-filled with water and under 95% nitrogen supervision. Note uniform appearance of pipe wall and absence of any localized pits.

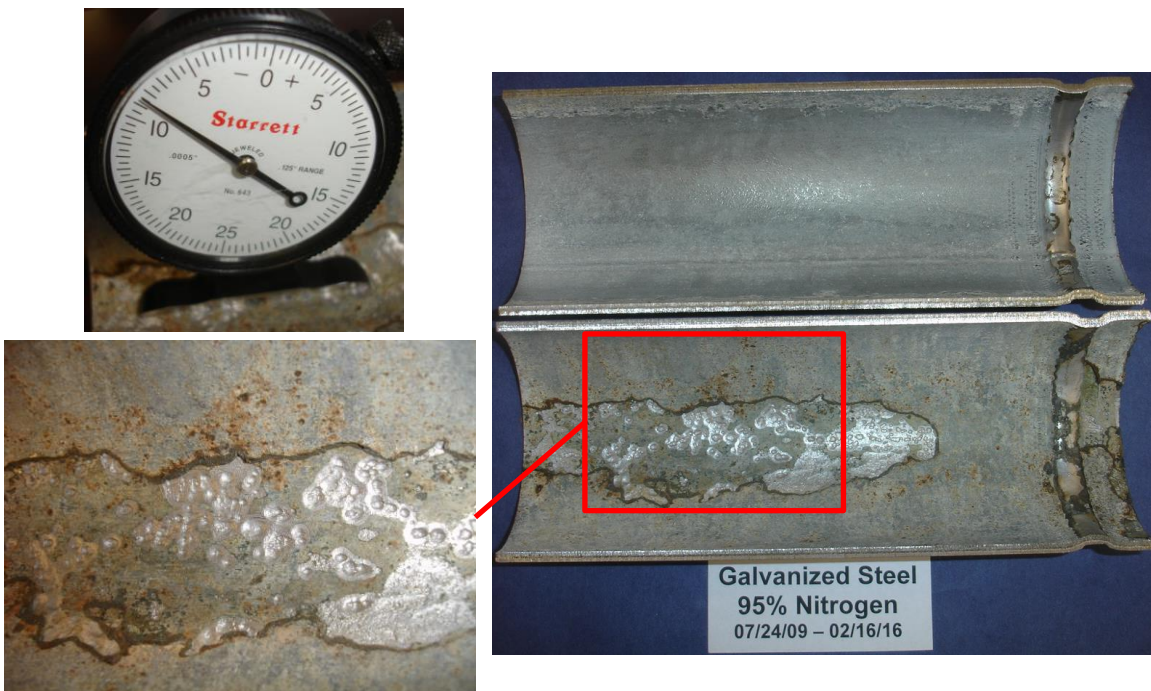
Figure 4. Composite image of cleaned galvanized piping after 2398 days exposure while half-filled with water and under 95% nitrogen supervision. Note the presence of localized pits in areas where zinc coating is no longer present.

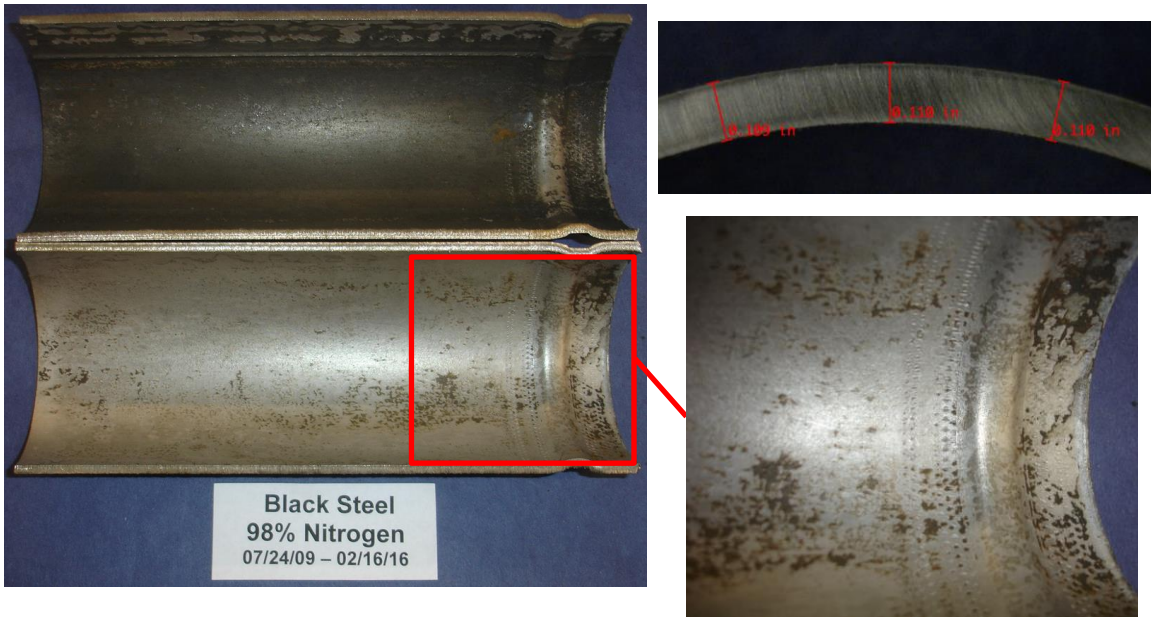
Figure 5. Composite image of cleaned black steel piping after 2398 days exposure while half-filled with water and under 98% nitrogen supervision. Note uniform appearance of pipe wall and absence of any localized pits.

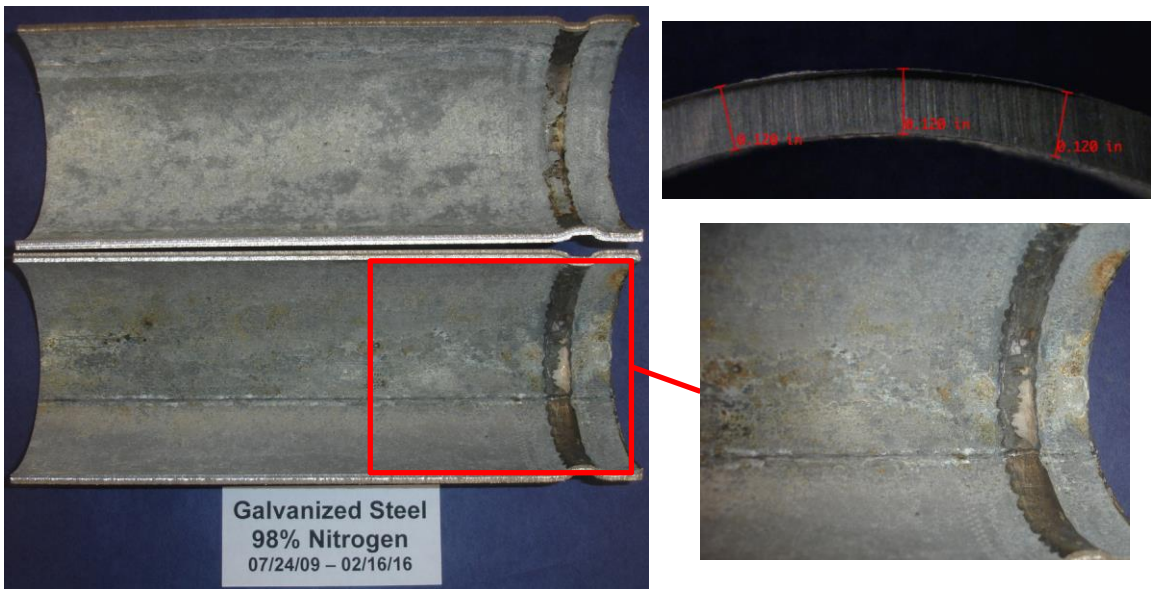
Figure 6. Composite image of cleaned galvanized steel piping after 2398 days exposure while half-filled with water and under 98% nitrogen supervision. Note uniform appearance of pipe wall and absence of any localized pits.
